St. Peter's Episcopal Church

RESTORING THE ALTARPIECE, 2016

150 Years of Wear and Tear

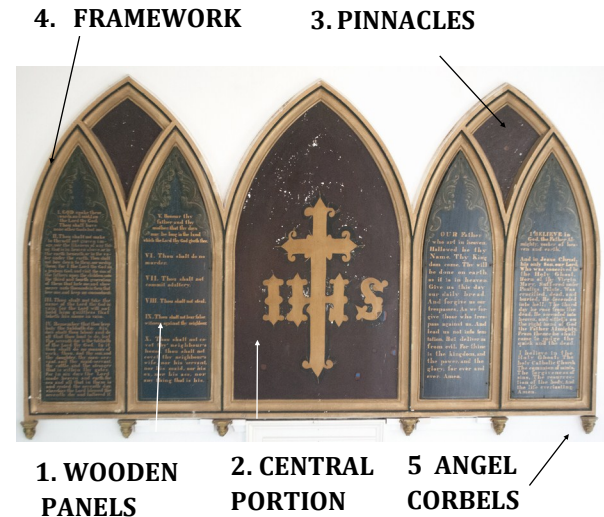
1. WOODEN PANELS—Flaking, cracks, bowing.

Two of the panels are bowing visibly and appear detached at the top. The paint and ground layers are cracking, exposing the ground and brighter blue of the field.

2. CENTRAL SECTION—Over painting, cracks.

The tablets have been damaged by overpainting. The maroon overpaint is flaking to the plaster over large areas of the panel, particularly in the upper third of the panel. There is a large crack extending through the lower edge of the frame and up into the painted panel.

3. PINNACLES— Flaking, cracking and overpainting. There was previous flaking of the original surface of the pinnacles. Divots in the overpainted surface indicate that there was extensive previous flaking of the original surface.

4. FRAMEWORK—Cracks, losses gilded surface loss. The tablets and the wall to which it is attached have suffered from moisture damage due to leaks along the roof flashing and cracks due to the earthquakes.

There are also cracks in the wall and plaster framework. There is fracturing in the lower left corner and upper left edges of the framework. There are missing sections such as that from the inner edge of the left-most arch. The original surface has been reduced and overpainted with gold colored paint. These layers have degraded, cracked and cupped. The surface is unstable and have an unattractive oxidized appearance.

Flaking - use of with a synthetic adhesive mixture, warmed in petroleum naphtha, and a small tacking iron.

Cracks -strengthened with linen patches and end-grain balsa wood blocks on the reverse, and the checks injected with an appropriate adhesive to stabilize them.

Cleaning - The paint surface will be cleaned on the obverse to remove the light surface grime and varnish.

Paint losses - Fill paint losses with a water soluble putty, and inpaint losses, scratches, and cracks to match the surrounding extant paint.

Cleaning - Clean to remove layers of overpaint with solvents.

Consolidation -Any original flaking paint will be consolidated as cleaning progresses.

Protective coating - After cleaning and consolidation are completed, apply a protective coating a Acryloid B-72 to the painted surface.

Paint losses -Fill paint losses, cracks, and low areas a water soluble putty, and inpaint losses to match the surrounding extant paint.

Repaint large areas of the upper part of the central panel.

Gold scrollwork -The gold scrollwork decoration on the pinnacles will be restored by comparing the two panels and copying the corresponding elements. Missing areas of gold will be in painted with titanium coated mica gold-toned powders.

Structural stabilization/repair to any framework elements that are loose or otherwise unstable.

Consolidation of all surfaces that are prone to further disintegration.

Application of an appropriate isolating layer - to separate historic materials from new work.

Cracks - Filling and other appropriate repair to cracks in framework.

Losses, chips, dents, scrapes, gouges, and other damage to the molding profiles - filling and other appropriate compensation for these issues.

Front and interior framework surfaces - Removal non-original paint layers. Application of a multi-layer painted finish that attempts to capture the spirit of the original gilded surface, including mica powder and various mediums at the conservator's discretion. For all exterior framework surfaces, application of a painted surface that blends with the white wall.
